### Power Industry

#### High Temperature Protection in a Desulphurization Plant

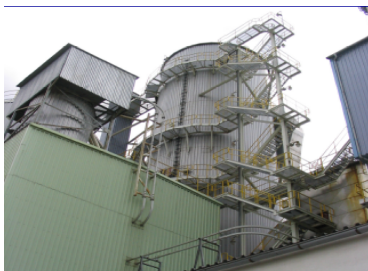
Following the failure of an epoxy coating after 3 years Corrocoat were asked to refurbish the internal coating of the absorber. XT was used on the upper areas where working temperatures were close to 200°C and VEF was used on the remainder of the absorber.

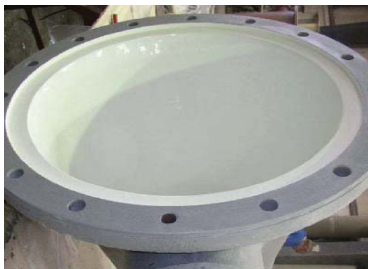
#### Cavitation, Undercutting & Severe Corrosion Around Flange Area

Corrocoat EA and EB series provide good resistance to erosion, cavitation and impact when used at thicknesses above 1.5mm. These cast iron components were originally glass lined and were fully refurbished with the above Corrocoat system.

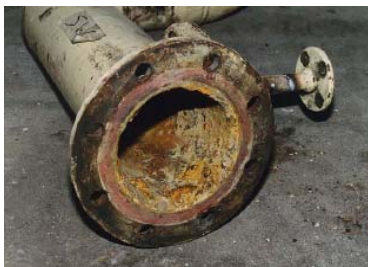
This pipe was coated with a low cost epoxy coating and had failed after 9 months due to poor preparation, heavy salt contamination, low bond and high permeation. Corrocoat removed the faulty coating, decontaminated the substrate and lined the pipe with Corroglass 600 series. The pipe has been in service for over 10 years with no problems.

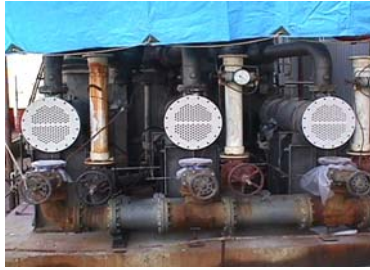
These heat exchangers were originally epoxy coated. On inspection the tube sheets were badly corroded and the client considered replacement of the tube sheets and tubes with 8 weeks down time. Corrocoat repaired and coated the existing sheets with 600 series in 4 days and at 10% the cost of replacement.

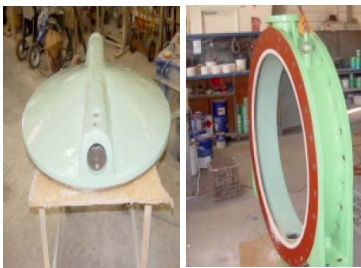
The valve flap and body had deep pits and metal loss around the sealing edges. As a result the valve had become totally ineffective. The valve was totally refurbished old for new with a 20 year life expectancy. The refurbishment of an existing valve can provide considerable savings over expensive metal castings or new valves with changes to pipework.

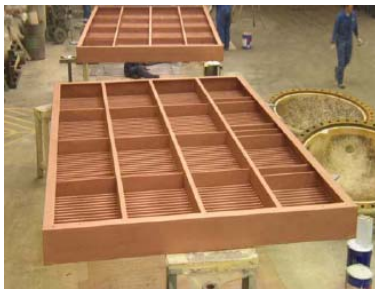
These screens were suffering from corrosion and marine growth. Corrocoat, blasted, decontaminated and patched the screens, then applied a 1.5mm coating of Polyglass 600 series to eliminate any future corrosion. A top coat of environmentally friendly Biofoul was applied to the screens as a long term anti foul treatment. The use of Biofoul has eliminated the costly requirement for regular cleaning and maintenance by divers.

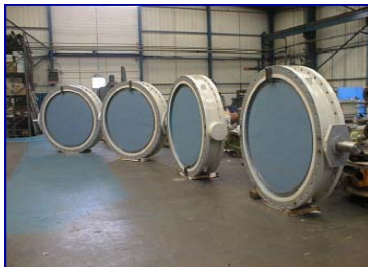
Corrocoat can protect and refurbish large butterfly valves. We have extensive knowledge of these large valves and our UK factory can manufacture valves from 1.25M dia to 3.35M dia. The addition of Corroglass 600 series when new will help protect these expensive assets and increases their design life considerably.
