### BHP Petroleum- Griffin Venture North West Shelf

Pipework coating

**Industry:** Oil & Gas  
**Product:** Corroglass 600 Series & VE Pipe Grade  
**Expertise:** Internal & External Coating of Pipework

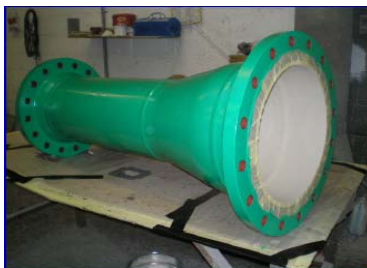
This reducing spool forms part of a seawater fire main. Without protection severe corrosion would occur rapidly in this aggressive sea water environment. The design life of the firemain was 15 years so Corrocoat was selected to provide corrosion protection internally with 600 series and external protection with ZF.

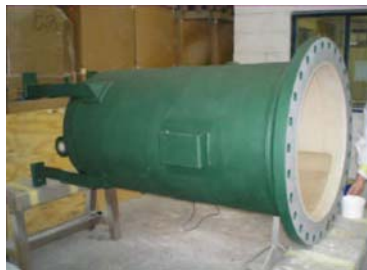
These new vessels are prepared by rebating the flanges to protect against crevice corrosion. Then Polyglass VEF and Corroglass 600 series is applied to the internal of the vessel to a thickness of 1250 microns. The external of the vessel is coated with Plasmnet ZF to combat atmospheric sea spray.

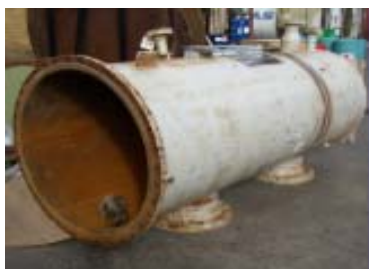
During the "algae bloom" period the baskets were removed several times a day causing mechanical damage to the coating. Corrocoat offered a solution of stainless steel impact rings and internally coated the internals with a corrosion and abrasion resistant lining. The strainers are now lasting in excess of 12 years before requiring maintenance.

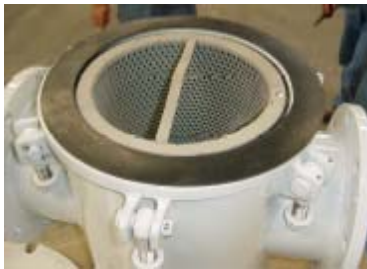
The original Strainer was rubber lined and after the rubber was removed considerable corrosion in weld areas and drain holes was discovered. All areas were blasted and treated with Chlo\*rid to remove salt contamination. Multiple layers of Corroglass 600 series were applied to a final thickness of 1.0mm and finally all surfaces spark tested to 8KV DC.

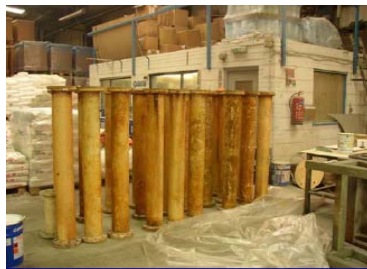
These pipes were originally coated in 1983 with Corroglass. They were exposed externally to seawater (immersed, splash zone & atmospheric) & internally to warm sea water before being removed for inspection in 2004. The coating was found to be in excellent condition, touched up & the pipes put back into service.

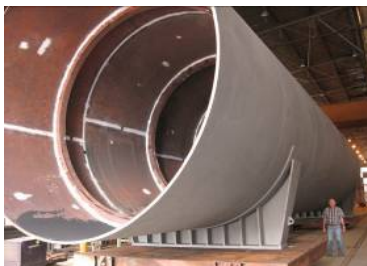
These bullets are buried in chloride rich coastal soil in a high rainfall area and the refinery found other coatings blistered within 5 years due to Cathodic disbondment. Polyglass VEF was selected and two coats to a thickness of 1500 microns was sprayed to the external of each bullet.
