Railway Bridge Maintenance

Industry: Structural Steel
Product: Polyglass Zipcoat
Expertise: Structural Coatings

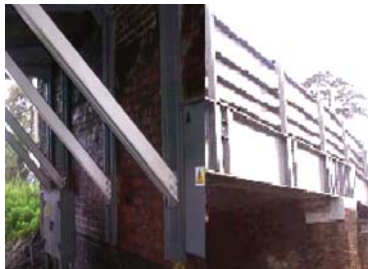
Zipcoat Approved by Highways Agency UK

Zipcoat's unique characteristics were a major factor in it being selected for railway bridges in the UK. The client required rapid cure at low temperatures, good gloss and edge cover and durable corrosion protection all in a single coat. Furthermore the mild steel bridge was coated in the middle of an English winter.

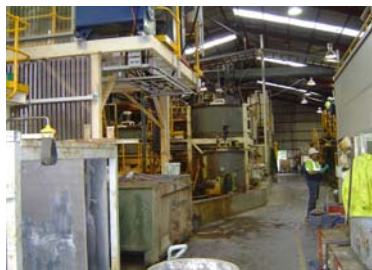
Mineral Processing Plant

Structural Steel & Equipment Protection - Tasmania

Industry: Process
Product: Polyglass VEF
Expertise: External coating of Steel work and Equipment

Chemical spills and an aggressive acidic atmosphere were damaging the structural steel and equipment in this mineral processing plant. Polyglass VEF was applied to all steelwork and equipment to increase the life of the structure, plant and equipment.

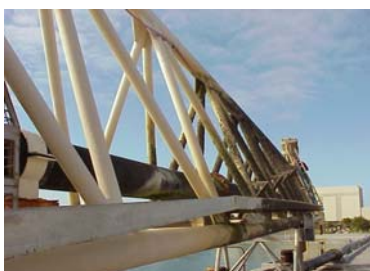
Salt Water Immersion

Structural Steel Work

Industry: Process
Product: Corroglass 600 series
Expertise: External Coating of Structural Steel

This reclaimer boom is immersed in sea water for the recovery of shell grit. The structural steel was sprayed with 750 microns of 600 series to provide corrosion protection in this harsh environment. As seen here after 2 years service the coating was found to be in excellent condition with a small amount of marine growth on the end of the boom.
